Maritime Engineering Journal

Edition No. 65

FALL 2009 / Winter 2010

Halifax-class Diesel Generator Failure Investigation

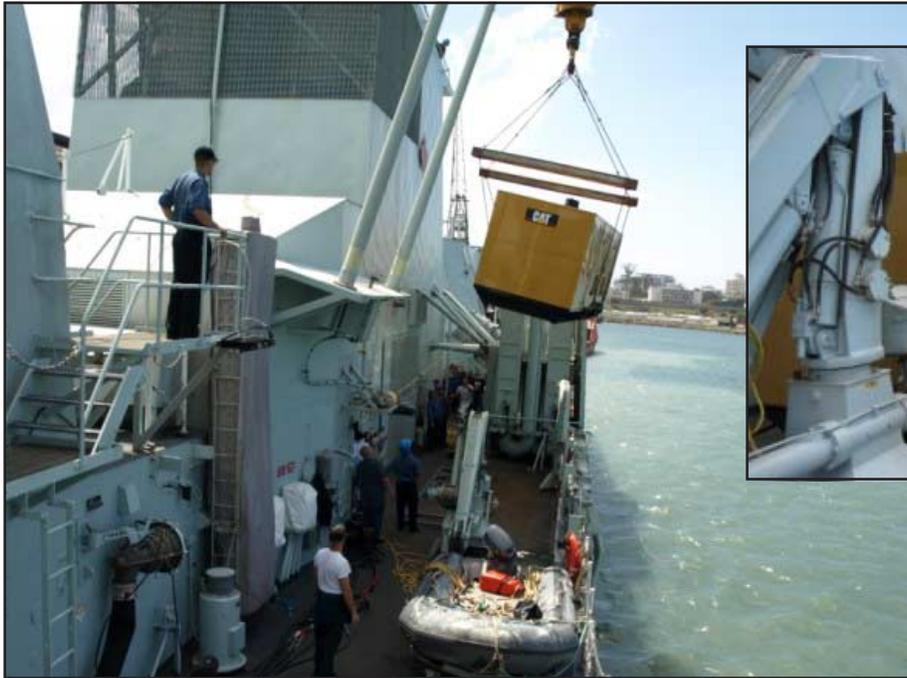
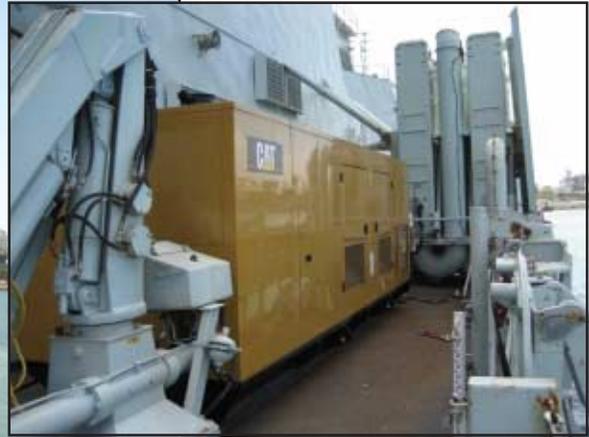
A tight fit on the port side. A less-than-ideal sling mechanism and minimal clearances on the superstructure complicated the installation.

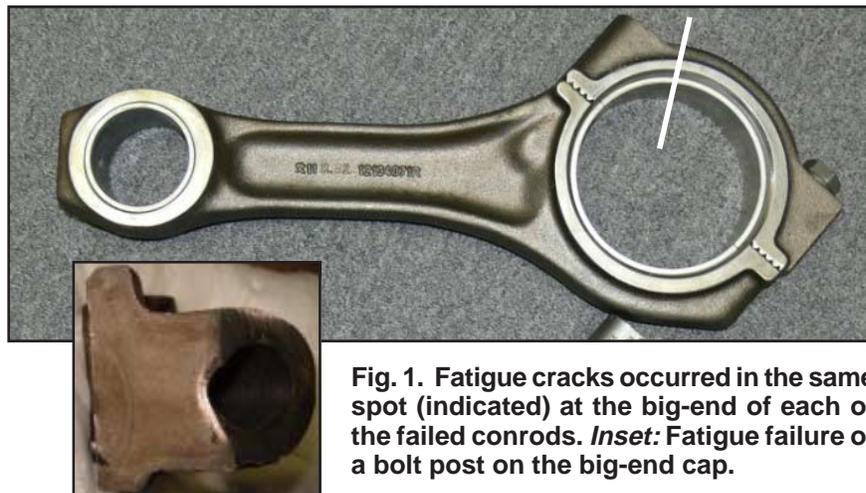
Fig. 1. Fatigue cracks occurred in the same spot (indicated) at the big-end of each of the failed conrods. Inset: Fatigue failure of a bolt post on the big-end cap.

The working group focused its investigation primarily on establishing a root cause for the conrod big-end cap cracking that was behind the majority of the recent catastrophic failures. Analysis conducted during the earlier technical investigations had determined that the cracking initiated at the same location on each conrod (*Fig. 1*), and that each failure had been caused by fatigue. Moreover, on each failure there were signs of a high degree of fretting, or abrasive wear, between the conrod big-end cap housing and the bearing, with significant levels of material transfer evident (*Fig. 2*). Early in its own investigation the working group concluded that the big-end cap cracking was being initiated by this fretting.

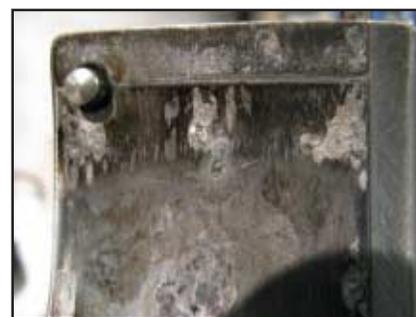
Fig. 2. The conrods showed a high degree of fretting and significant levels of material transfer between the big-end cap housing and the bearing.

fleet of engines, three under the same part number. The most recent version included a material change and was the only version not to have suffered a failure. It is likely this conrod version has greater material strength and is less susceptible to fretting and fatigue cracking. Material strength was classified as a possible contributing cause, but not a root cause since the engines had operated with the previous three versions for over ten years without big-end cap failures.

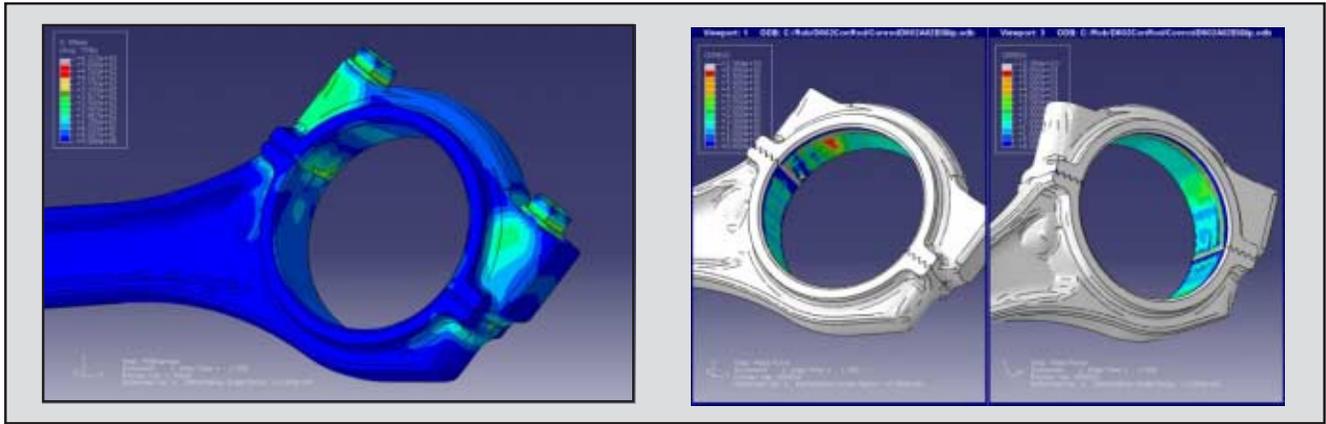
A computer finite element analysis (FEA) model built by Wartsila revealed that the conrods did indeed have a risk of fretting at the crack location, and that a high stress point exists at the same location. Both were due to mass forces (*Fig. 3*) and gas forces.

Fig. 3. Finite element analysis results for mass forces acting on a conrod indicate (left) the maximum stress points, and (right) fretting contact pressures.

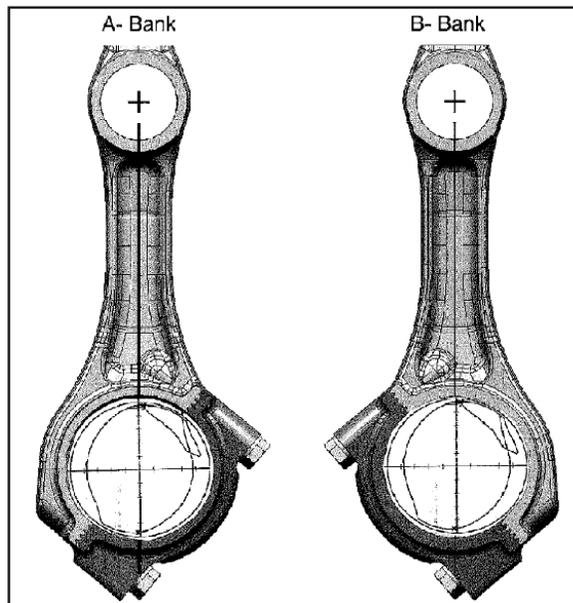
Fig. 4. Oil film analysis reveals maximum forces being exerted at different points on A-Bank and B-Bank conrods. The A-Bank conrods (left) were at much greater risk since the forces were acting on the weak point of the housing at the big-end cap serrated connection point.

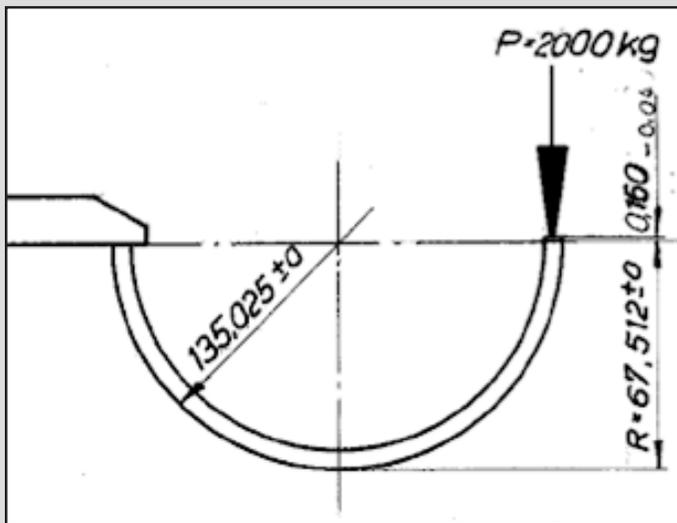
The conrod big-end bearing is held in place within the housing by an interference fit. This is achieved via an overstand nip length of the bearing, essentially oversizing it to the housing (*Fig. 5*) so that it compresses into position. Possible causes of inadequate interference fit can be attributed to:

Fig. 5. The circumferential length of the bearing should be slightly longer than the circumference of its housing in the conrod big-end. A proper interference fit of the bearing with the housing is achieved when the “nip” crushes into position when the conrod cap is bolted down. An undersized bearing, and thus too short a nip, would allow the bearing to fret, or move about, inside the big-end housing.

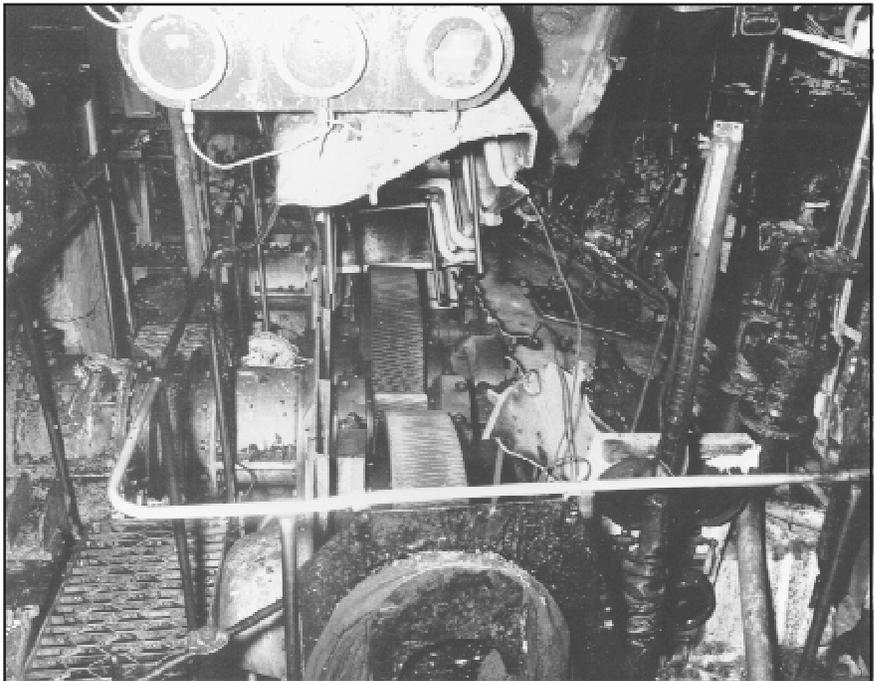
Fig. 1. The blackened engine room of HMCS *Kootenay* in the aftermath of a devastating gearbox explosion and fire bears dark witness to the horrific events of October 23, 1969. An improperly assembled forward pinion journal bearing lay at the heart of what should have been an avoidable tragedy. (All photographs property of DND)

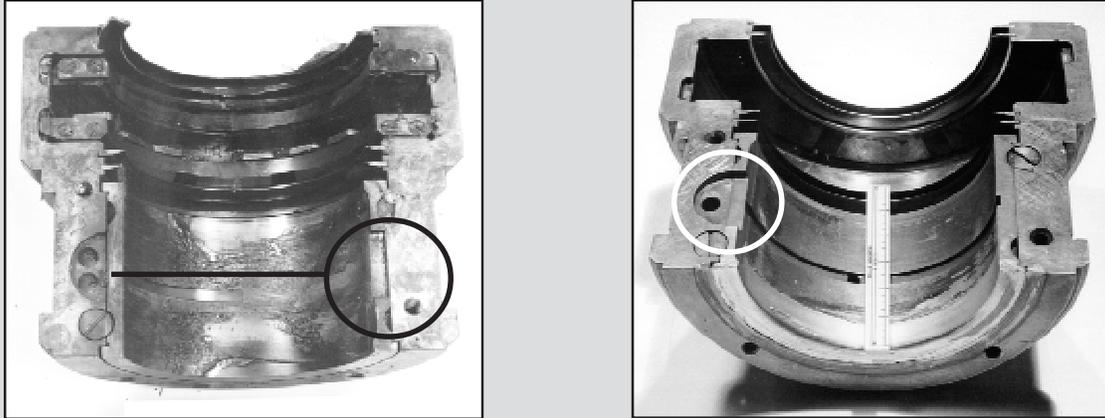
Fig. 2. These two pinion bearing halves from *Kootenay* (left) and *Chaudière* (right) illustrate the difference between incorrect and correct assembly of the bearing inserts. In *Kootenay*'s starboard forward bottom-half bearing the insert is installed back to front such that the cut-out (black circle) to allow oil into the insert is opposite the lube oil inlet port at left. In *Chaudière*'s port forward top-half bearing the cut-out (white circle) is properly matched to the oil inlet.

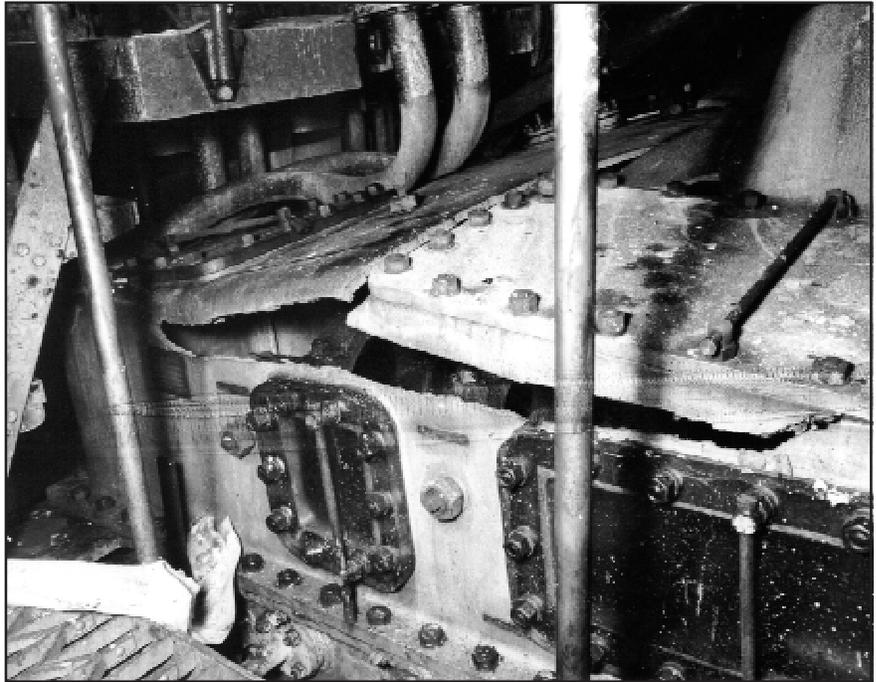
Fig. 3. The violent force of the explosion inside *Kootenay*'s gearbox ruptured the aluminum gear casing. Steel is now used in place of aluminum in modern gearbox covers.

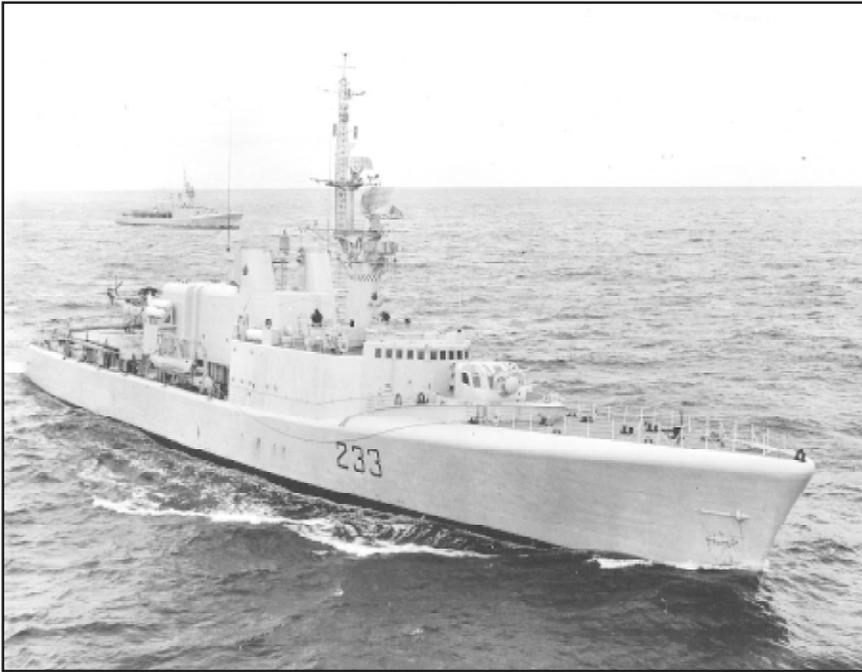
Gearing incidents in four other destroyer escorts in the two years following the 1969 *Kootenay* explosion highlight the need even today for attention to detail with all matters of engineering maintenance, and constant vigilance over machinery. (HMCS *Fraser* shown.)
