Maritime Engineering Journal

Edition No. 65

FALL 2009 / Winter 2010

Halifax-class Diesel Generator Failure Investigation

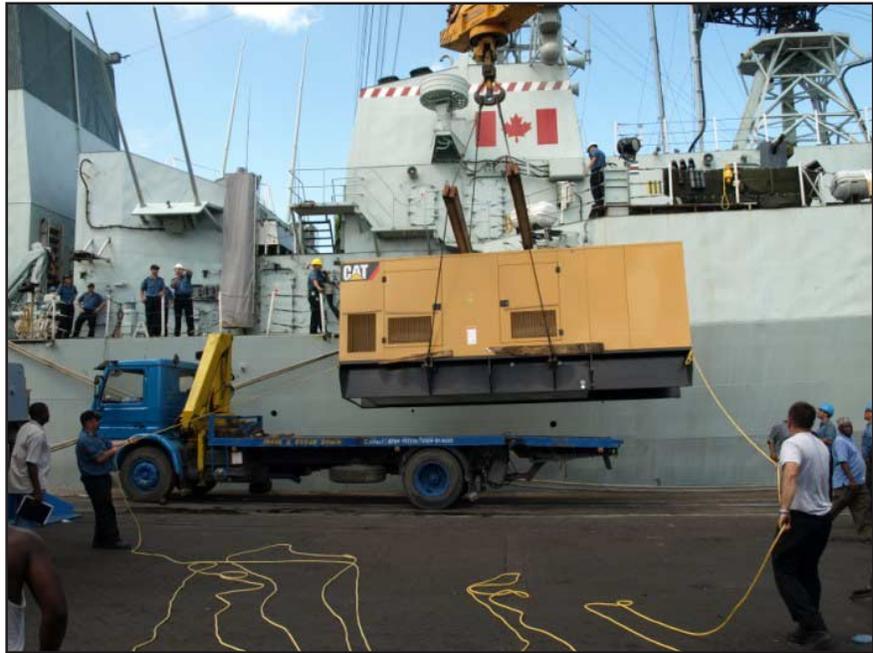
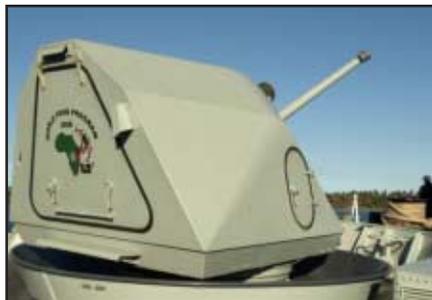
HMCS *Ville de Québec* loads one of two emergency replacement diesel generator units in Dar Es Salaam, Tanzania while deployed in support of the United Nations World Food Program. The ship's gunshield artwork at left depicts "Lucky Luke" on the job. (All photos courtesy the author.)

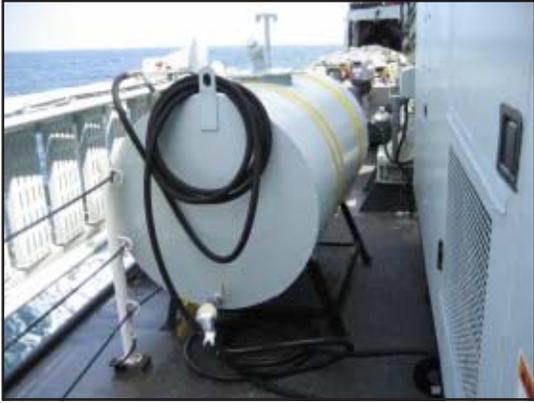
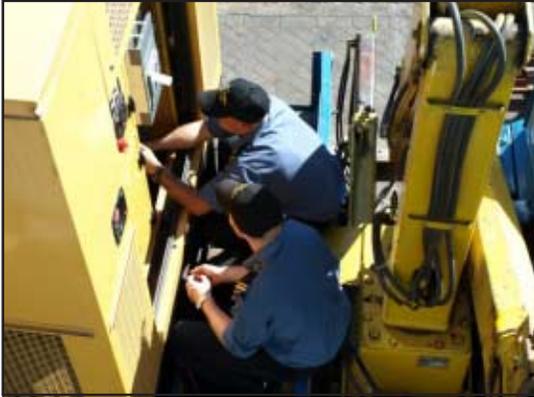
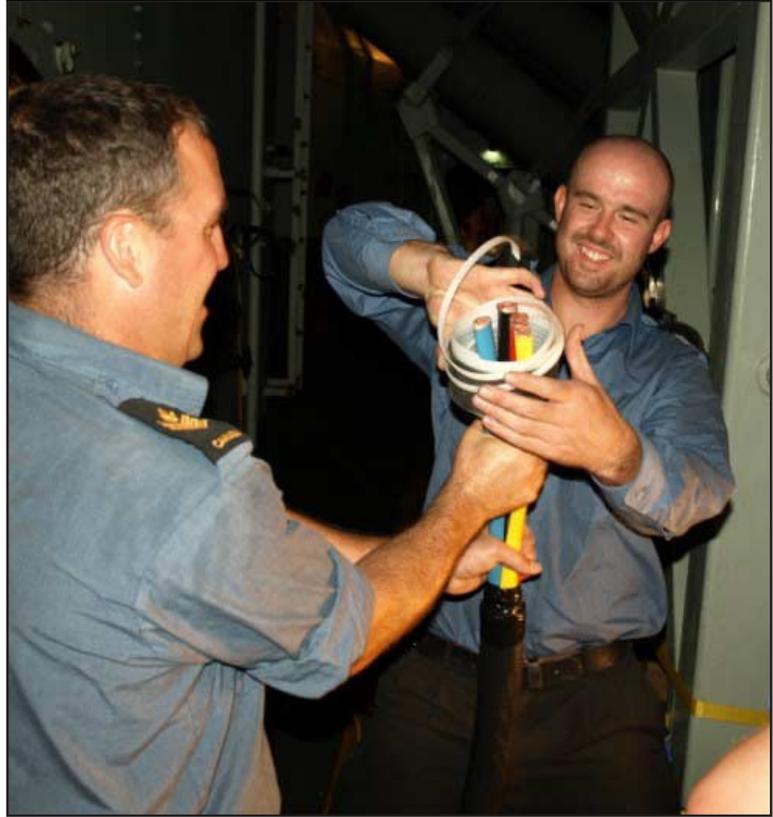
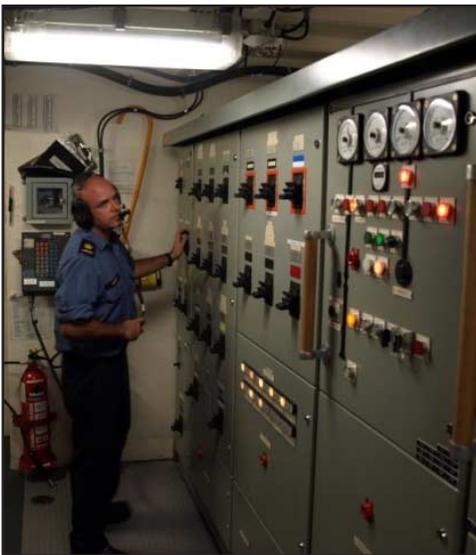
With the installation of an external fuel tanks (top), and the final electrical hook-ups and tests, the ship was “good to go.”

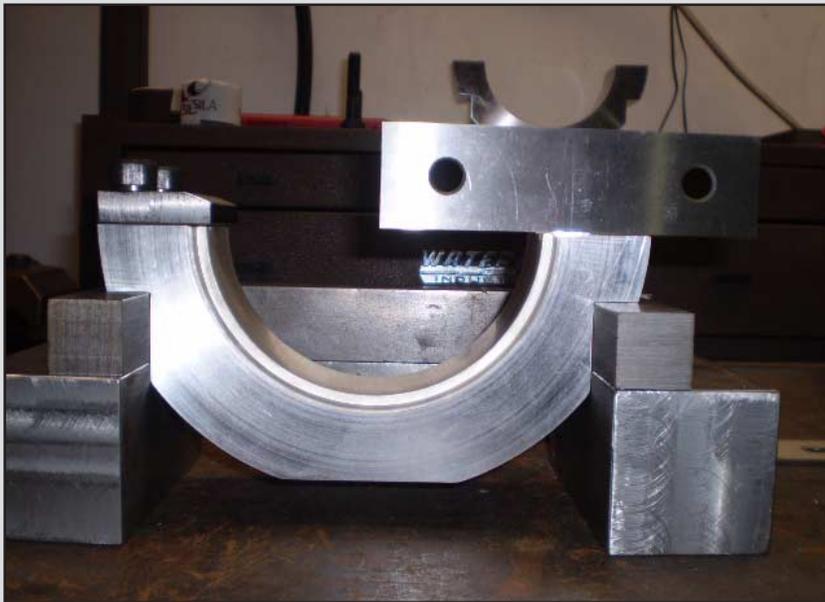
Fig. 6. Wartsila Canada’s Halifax facility manufactured this highly accurate jig to measure nip lengths of the conrod bearings.

Wartsila Canada’s Halifax facility undertook to measure the nip length on representative bearings, which required the manufacture of a highly accurate jig (*Fig. 6*). The measurements revealed the nip length to be short compared with the engine specifications, and so at the time of the first working group meeting nip length was categorized as a possible root cause.
